KENALL THE COMPETITIVE **EDGE**

Issue #7

The EnviroPro™ IN9 Series

Galvanic Corrosion: What It Is, Why It Happens & How Kenall Rises to the Challenge

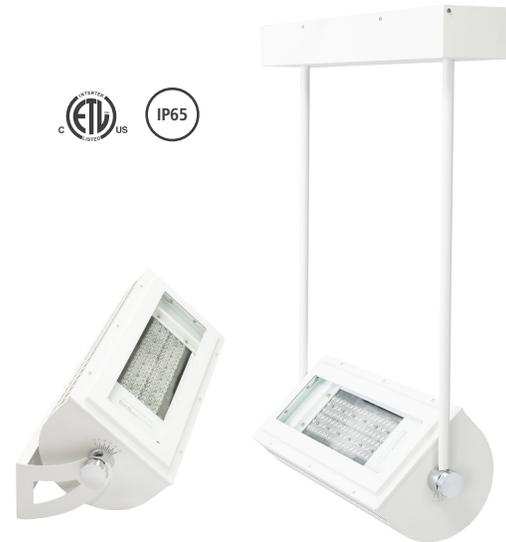
For natatoriums, Kenall's EnviroPro IN9 luminaire design takes the protection of 316 stainless steel even further. The entire luminaire, including the pendants, wall-mount brackets, hubs and hardware are all manufactured with consistent materials to prevent galvanic corrosion in this hot, humid, caustic environment. The luminaire is IP65 rated to protect against the ingress of moisture and contaminants, shielding internal components from damage. *The extra care with which this series is designed allows Kenall to offer the first 15-year mechanical warranty within the industry on luminaires specified with 316 stainless steel.*
